ACCIDENTAL VALVE EJECTION KEG AND VALVE ANALYSIS

January 07, 2015

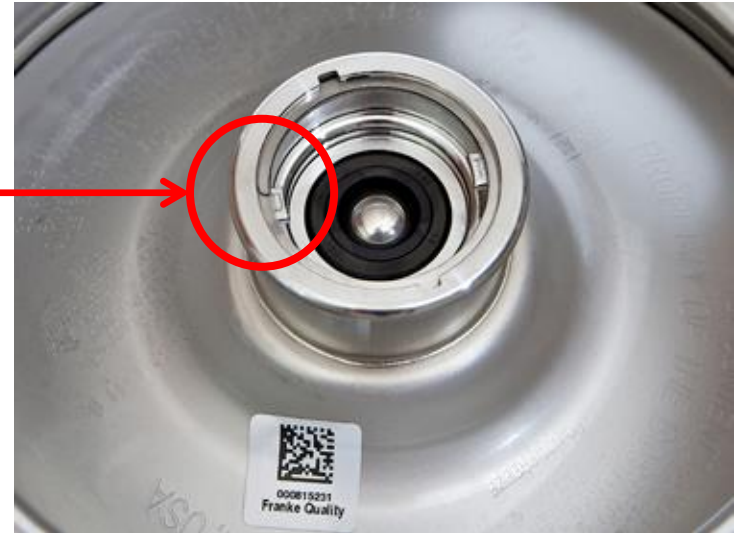
- **Proper Lock Ring Installation**

The end of the lock ring should always be located approximately 45 degrees from the ear channels. This prevents the lock ring from becoming accidentally dislodged when the coupler is being installed or removed

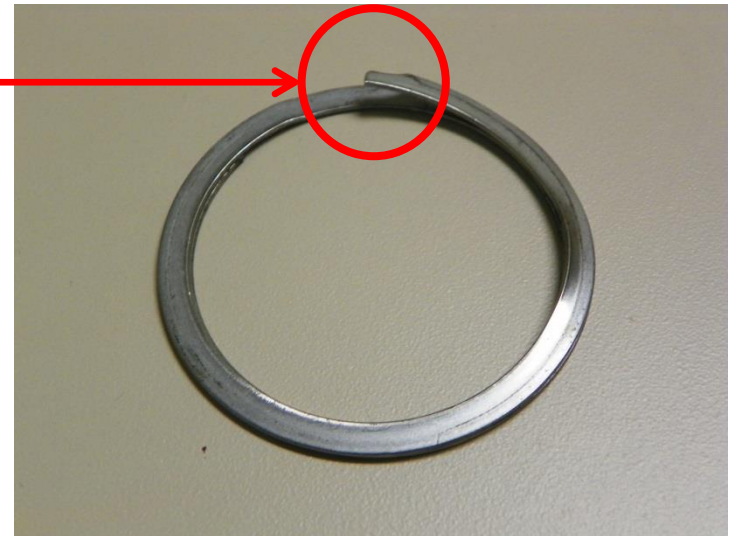
- **Lock Ring Damage**

When removed from the neck, the lock ring becomes damaged and unsafe for future use. The end of the lock ring will usually bend up, which makes the lock ring more likely to come out of its channel with frequent use.

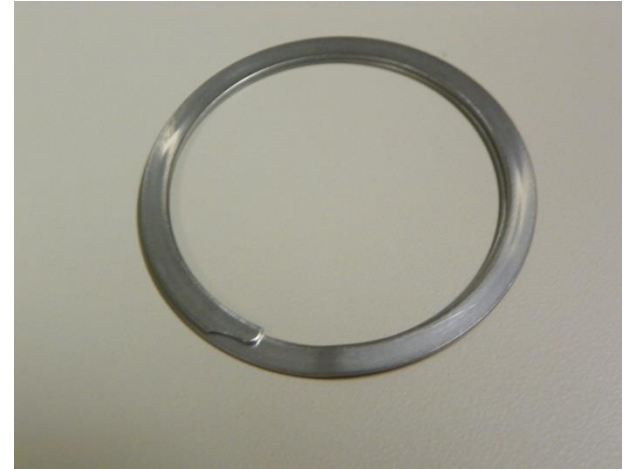
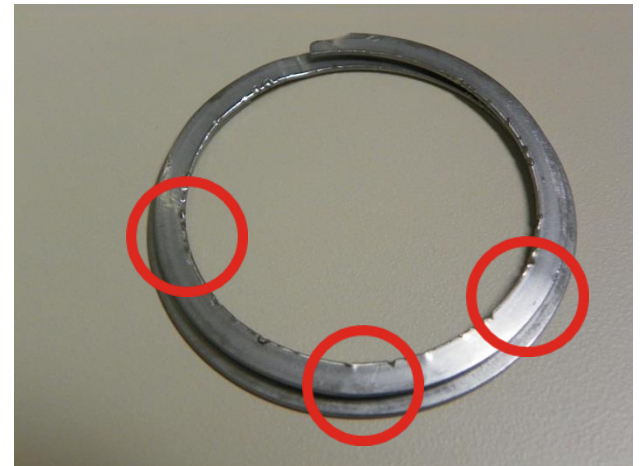
LOCK RING DAMAGE

- New lock ring
- Lock ring with evidence of tampering. Note the multiple impact points similar to those made by a flathead screwdriver. In addition, the overlapping sections of the lock ring are no longer flush

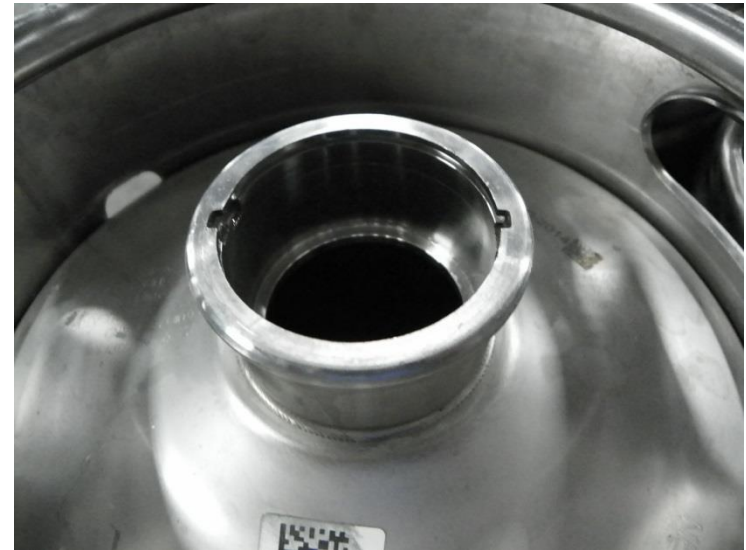
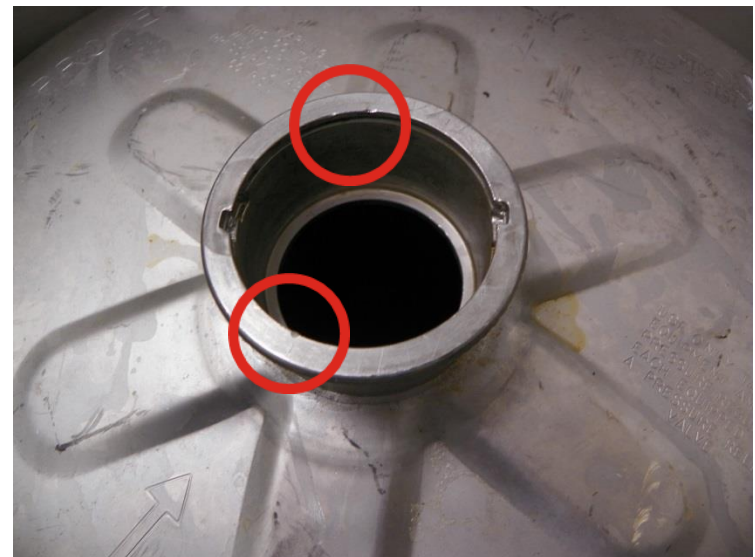
DAMAGED NECK

- Normal Neck
- Neck with signs of tampering. Note the multiple impact points similar to those made by a flathead screwdriver

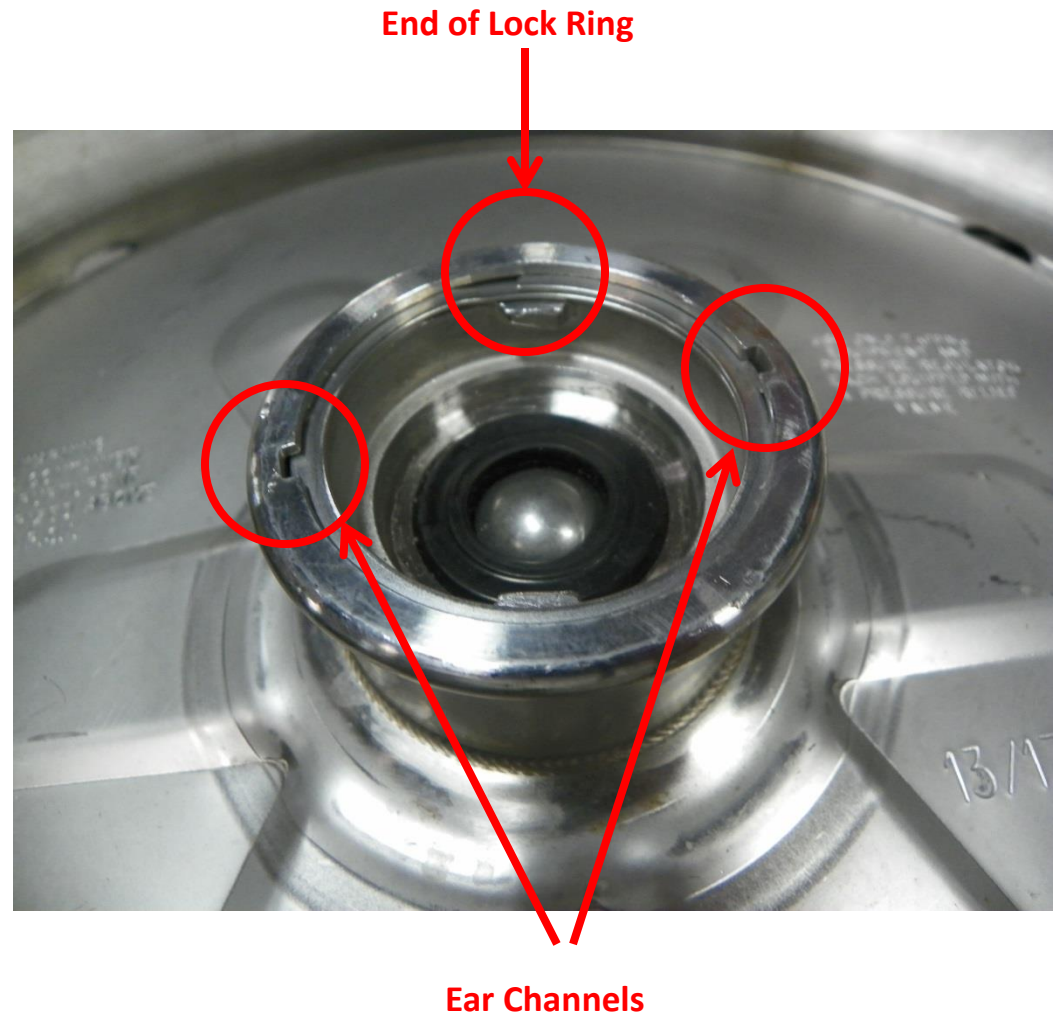
PROPERLY INSTALLED LOCK RING

- No noticeable deformation on the lock ring
- End of lock ring 45 degrees from the ear channels

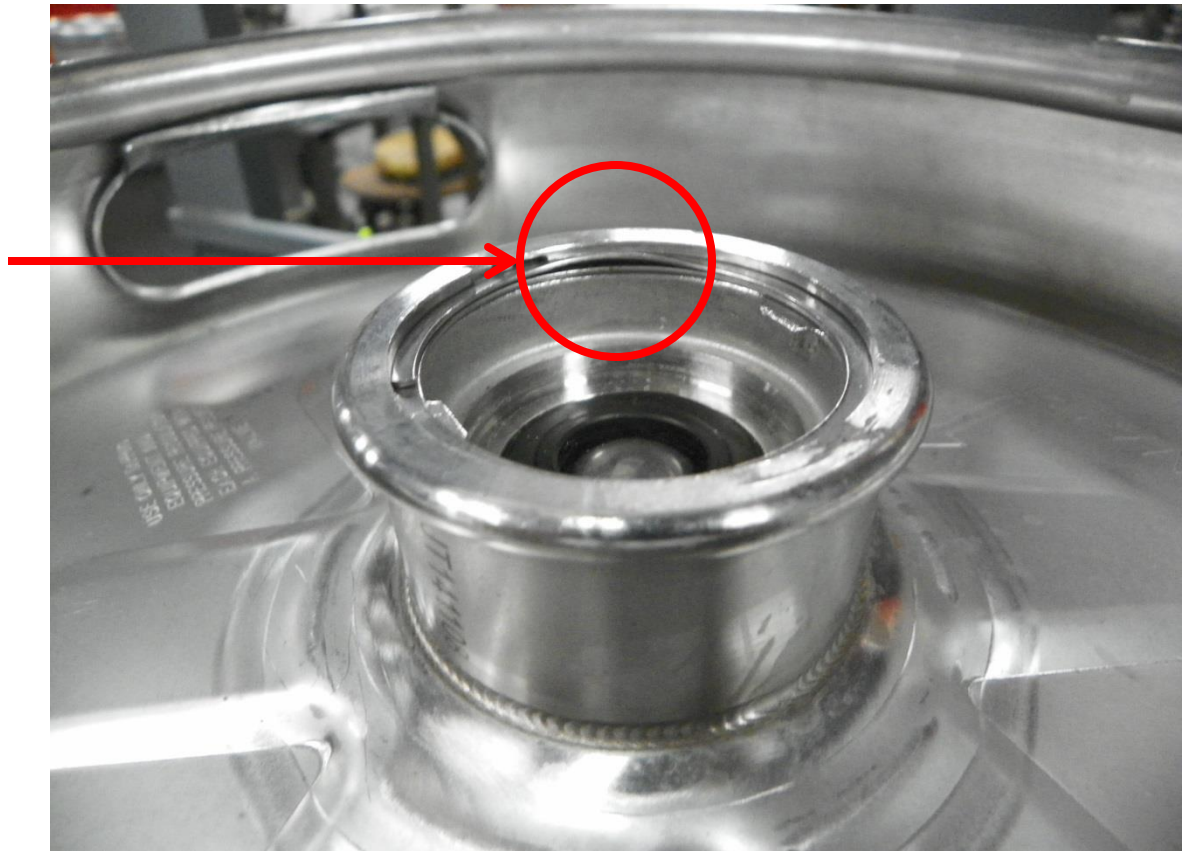
PREVIOUSLY USED LOCK RING

- Deformation to the lock ring caused during the removal process prevents the lock ring from seating properly in the lock ring channel
- **Note the gap in the lock ring resulting from deformation caused during the lock ring removal process**

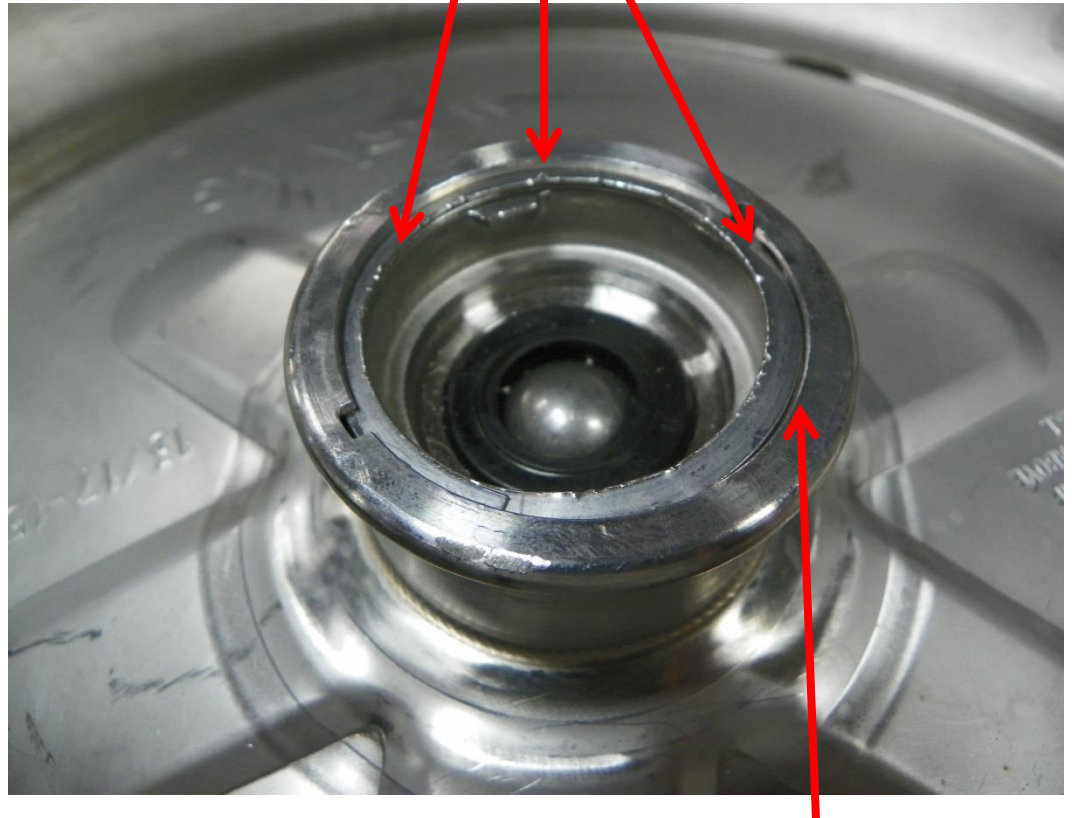
LOCK RING FROM INCIDENT

- The inside of the lock ring shows multiple impact points
- In addition to the impact marks, the bent ear prevents the lock ring from fitting all of the way into the lock ring channel

Multiple impact marks around the inner edge of the lock ring

Bent ear prevents the lock ring from fitting into lock ring channel

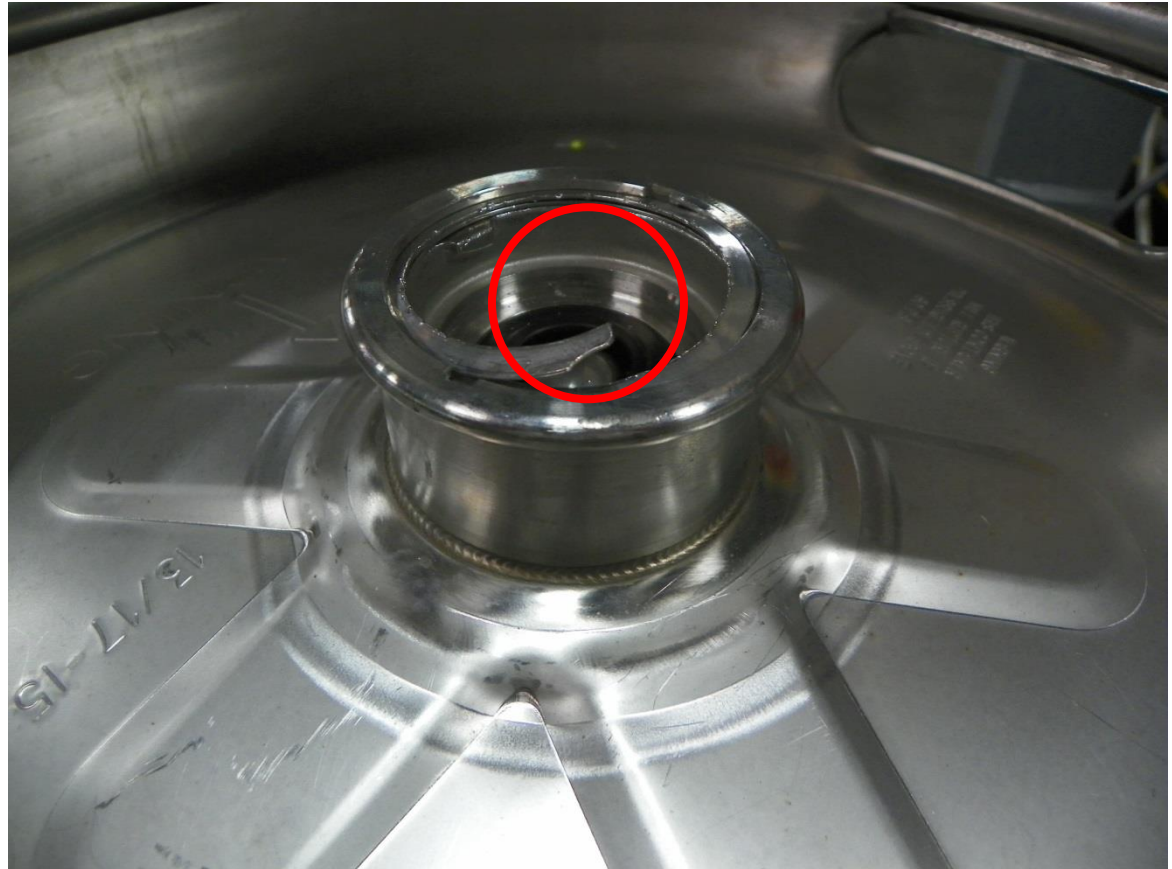
LOCK RING FROM INCIDENT

- In addition to the impact marks on the lock ring, the end of the lock ring is now protruding out of the ear channel
- With the lock ring protruding out of the ear channel, the lock ring can easily come out when installing or removing a coupler
