ACCIDENTAL VALVE EJECTION KEG AND VALVE ANALYSIS

January 07, 2015

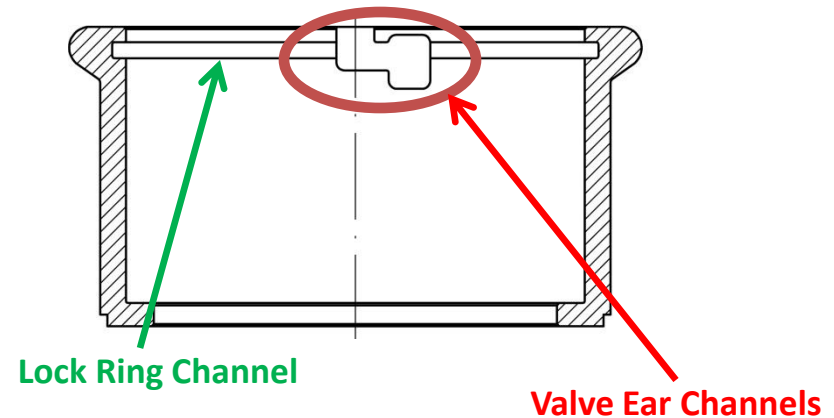
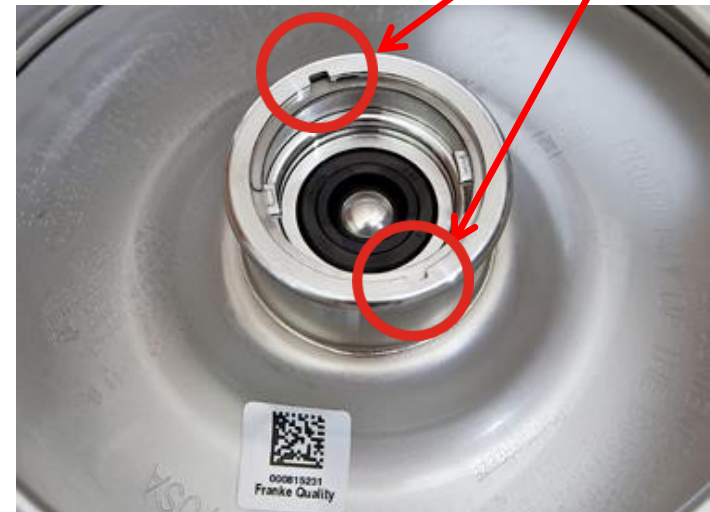
Kegs in North America have a specifically designed 304 stainless steel neck that aligns with a specially designed valve.

The valve and neck have two safety features:

- A 304 stainless steel lock ring that fits into a channel of the neck and prevents the valve from ejecting under pressure.
- Valves have 2 lugs, or “ears”, on the top that fit into two channels and prevent the valve from ejecting
